# Manhole Inspection Summary

Manhole # S37Q\_\_035MH

Insp Date: **1/16/08 1:47 PM**

**Location** Address: **432 e.cross st**

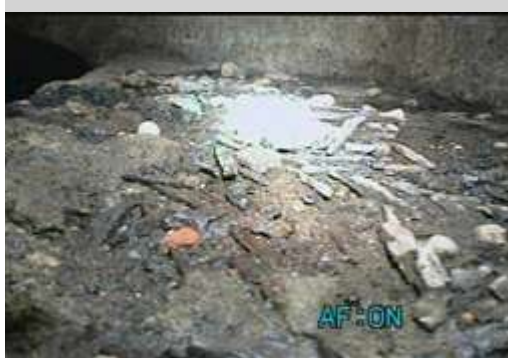
Defect 4

Condition: ☐ Sound ☐ Cracked ☐ Root Intrusion ☐ Deteriorated ☐ Leaks ☒ **Debris**

bench debris

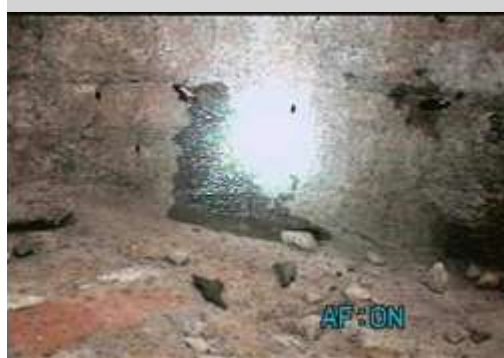
Defect 3

Infiltration: ☐ None ☒ **Joint** ☐ Cracks ☐ Mortar ☐ Roots ☐ Wall

infiltration in barrel

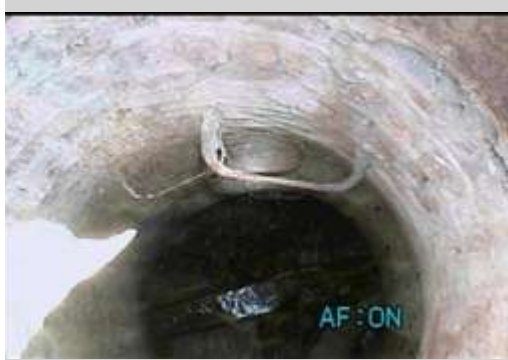
Defect 2

Count: **5** Missing: **0** ☒ **Corroded**

steps

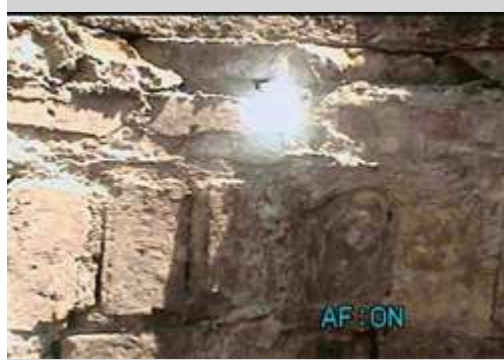
Defect 1

Condition: ☐ Sound ☐ Cracked ☐ Root Intrusion ☒ **Loose Brick** ☒ **Deteriorated**

chimney loose bricks,deteriorated,  
frame adj

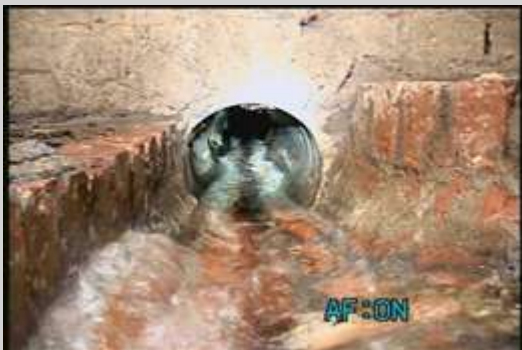
12 O'Clock Outflow

8 in. Circular Gravity Sewer  
Pipe Out @ 12 O'Clock

Invert Depth: **10.00** (ft.) Flow Characteristics: **Fast**

Deposits: ☒ None ☐ Mud ☐ Sludge ☐ Debris ☐ Grease

Infiltration: **None** Pipe Seal Cond: **Unknown**

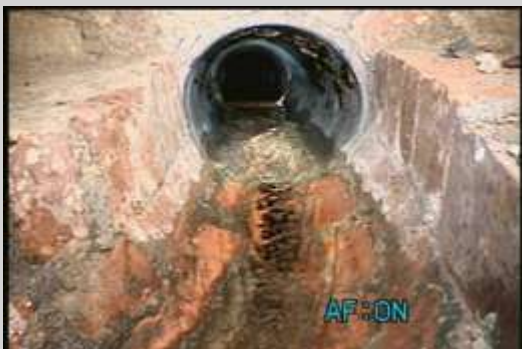
3 O'Clock Inflow

8 in. Circular Gravity Sewer  
Pipe In @ 3 O'Clock

Invert Depth: **9.40** (ft.) Flow Characteristics: **Fast**

Deposits: ☒ None ☐ Mud ☐ Sludge ☐ Debris ☐ Grease

Infiltration: **None** Pipe Seal Cond: **Unknown**

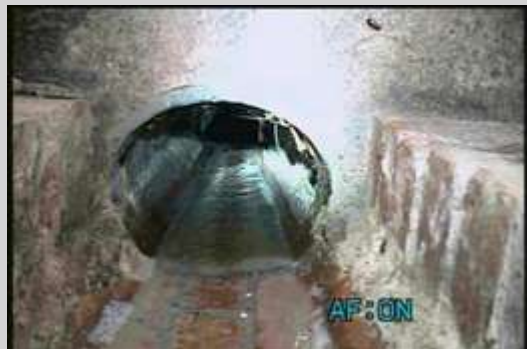
6 O'Clock Inflow

8 in. Circular Gravity Sewer  
Pipe In @ 6 O'Clock

Invert Depth: **9.80** (ft.) Flow Characteristics: **Slow**

Deposits: ☒ None ☐ Mud ☐ Sludge ☐ Debris ☐ Grease

Infiltration: **None** Pipe Seal Cond: **Unknown**
